Vegetation Impact on the Morphodynamic Activity of the River Kapuas

Original Research Article

Aims: To have the clear understanding of the causes behind the spatial variability of the morphodynamic activity of the river Kapuas, West Kalimantan, Indonesia.

Study Design: This study was designed to focus on the vegetation impact on the morphodynamic activity of the river Kapuas based on the Normalized Difference Vegetation Index (NDVI) using Landsat images.

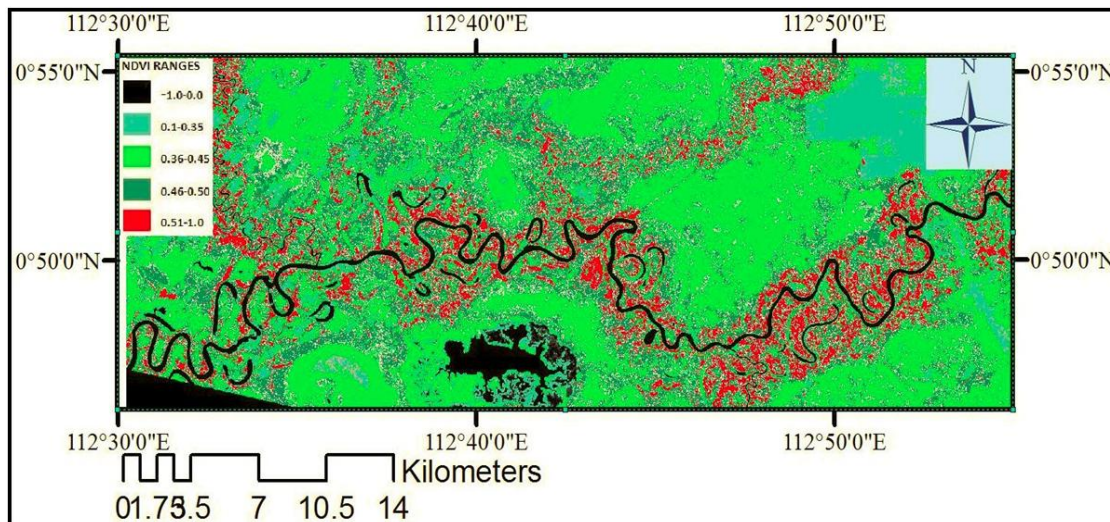
Fig. 3. NDVI map of the upper upstream of Kapuas River, 2013

With the band math calculation in ENVI4.8, the NDVI values of the whole study area were plotted by using the following equation.

(red) and near-infrared regions, respectively. NDVI values vary between -1 and 1. The values from -1 to 0 indicate vegetation free surface, like bare soil, and water bodies, and they were grouped together as a value of 0. Around the Kapuas, the whole study area is covered by more or less vegetation except for the water bodies, open crop field and urban area. NDVI values of the whole study area were plotted between the year 1991 and 2013 and the ranges of values were regrouped into different colour codes (Fig. 3) One pixel area (30 m x 30m) represents one NDVI value, but within this pixel area the NDVI values may be different. To get a view of different NDVI values within the pixels, the contour lines of the same NDVI value were plotted that helped to identify land cover types of the same vegetation even in one pixel. In case of the same NDVI values for different land cover types (from the unsupervised classification) or the other way round, the spectral profiles of middle infrared bands were used to separate the land covers as well as vegetation types.

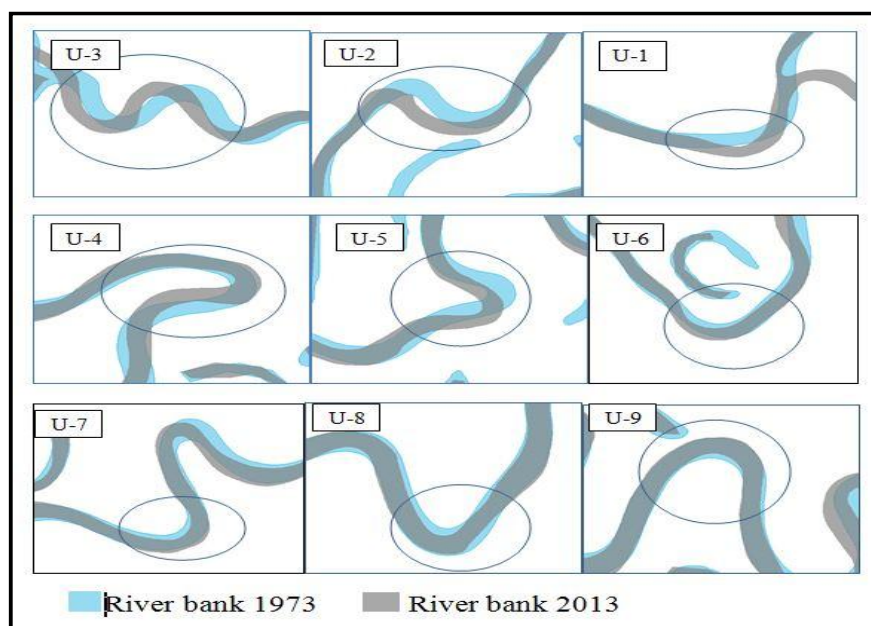
Fig. 6. Selected morphological units with focusing area (ellipse) in the upper upstream of kapuas river

To show the clear migrated area, the morphological units were selected only in the upper upstream area as the migration rate was comparatively higher in the upper upstream area than the downstream area. The migrated areas are shown in the Fig. 6.

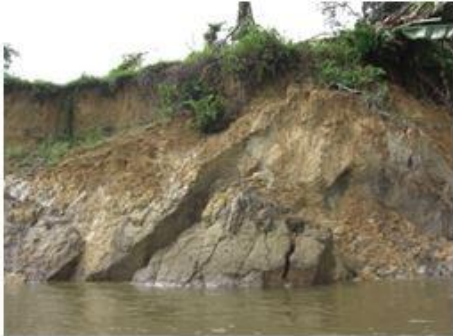
Mass failure of Banks without vegetation

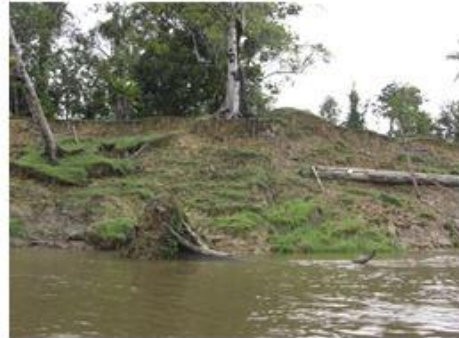
Migrated banks without vegetation

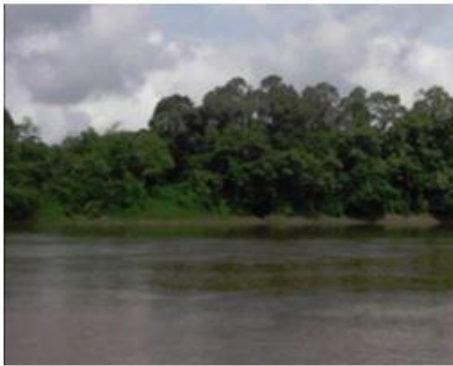
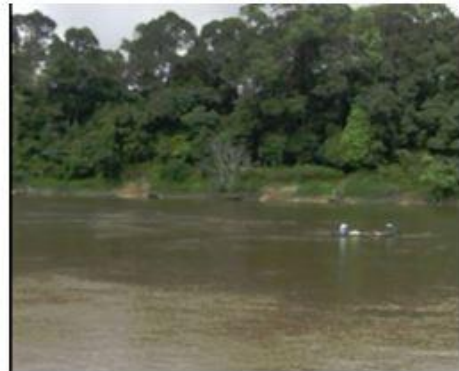
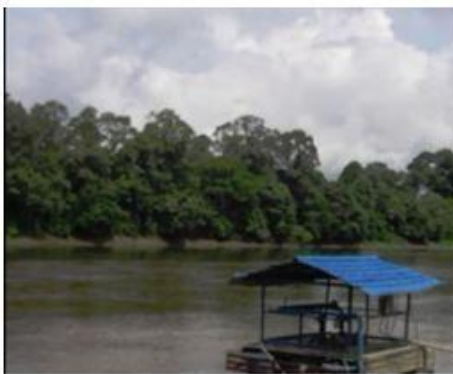
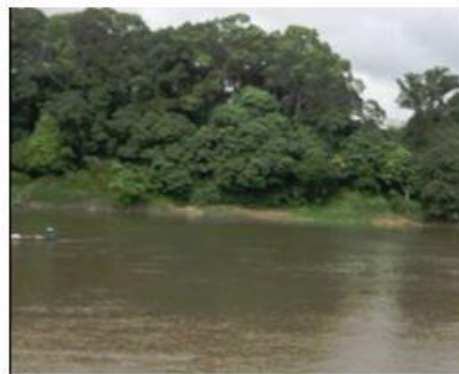
Stable bank with Vegetation

Stable bank with vegetation
