Journal of Engineering Research and Reports

A Study of Wafer Backgrinding Tape Selection for SOI Wafers

Bryan Christian S. Bacquian[1] and Frederick Ray I. Gomez[1*]

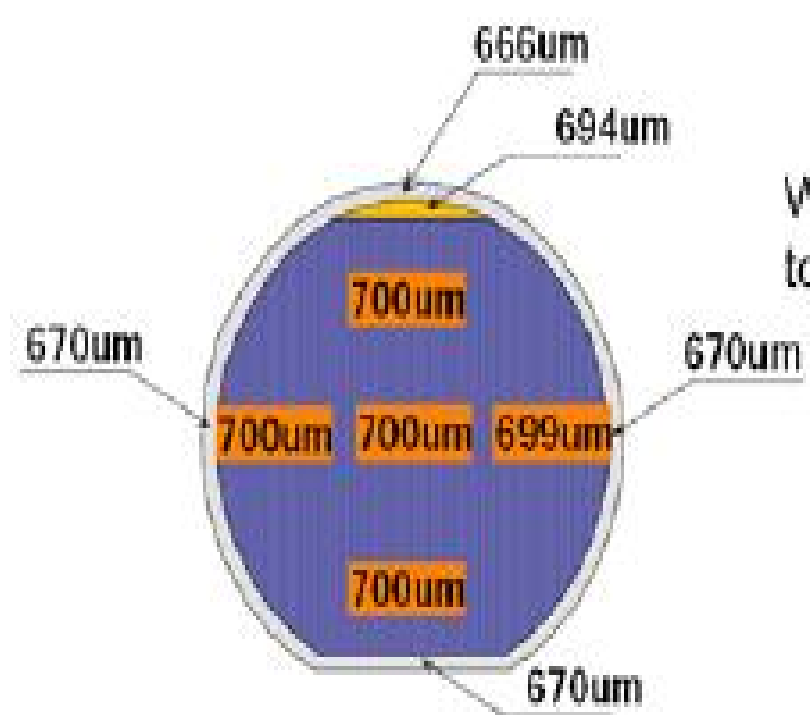
In line with the stepping effect, SOI wafers are measured prior wafer taping and observed to have the edge area 30μm thinner than the device area as depicted in Fig. 2. Also, the wafers after having taped are observed to have a warpage in Fig. 3 of 0.5mm around the edge area.

Fig. 2. Wafer thickness prior taping

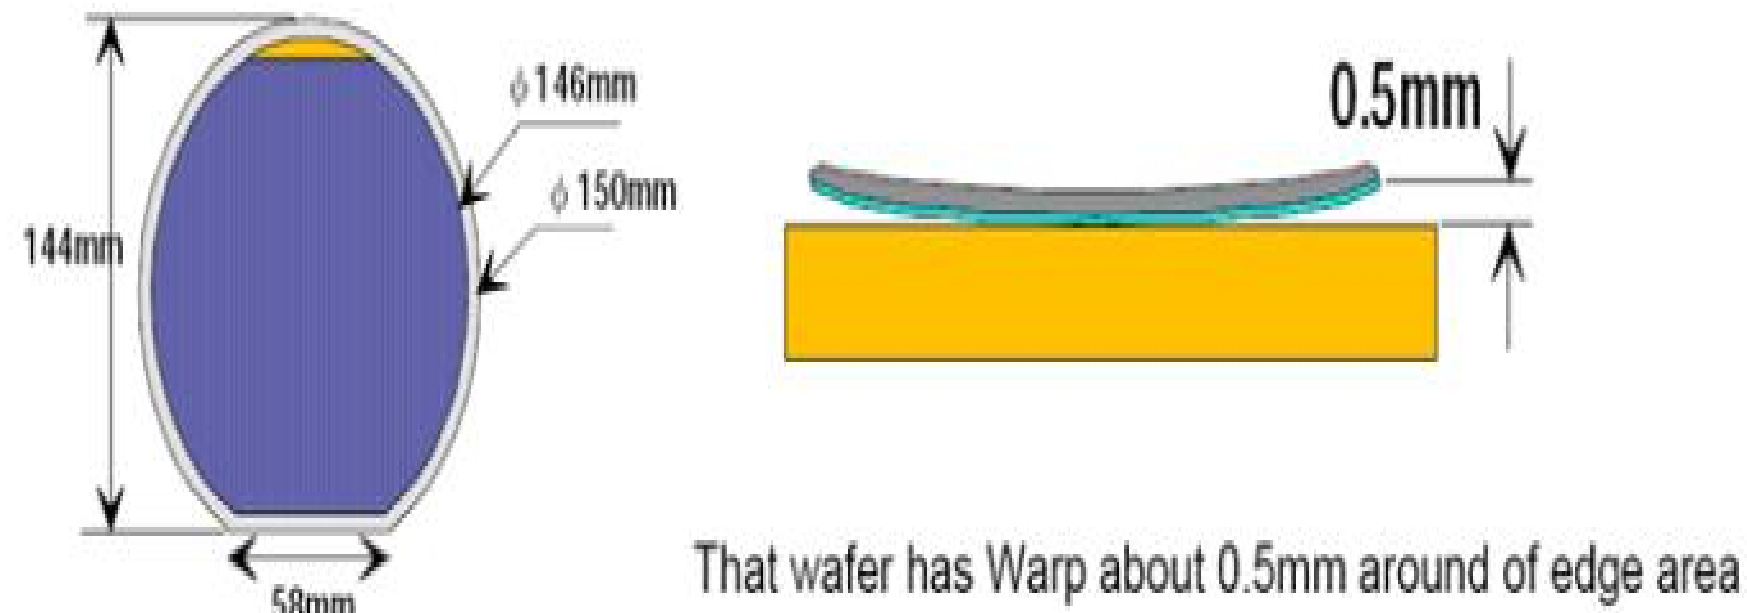
Fig. 3. Wafer warpage after taping

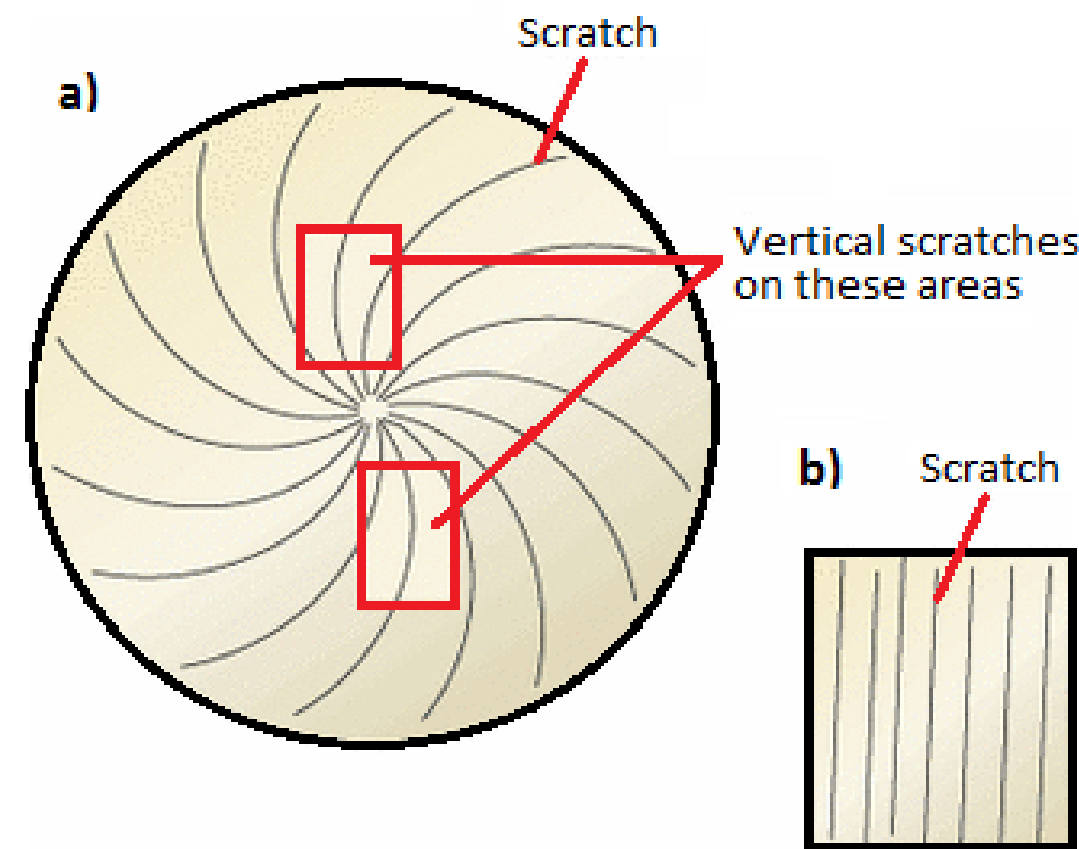
Fig. 5. Vertical scratches after wafer backgrinding

After backgrinding, the wafer will exhibit a scratch pattern on the backside as shown in Fig. 5. These scratch patterns and the depth of the scratches on the surface of the wafer are directly proportional to the size of the grit and the pressure exerted on the wafer during the grinding process. The depth of the scratches and the backside surface roughness of the semi-conductor die have a direct correlation to the strength of the die, so it is critical that the finished backside surface of the wafer be as smooth (or polished) as possible [8].

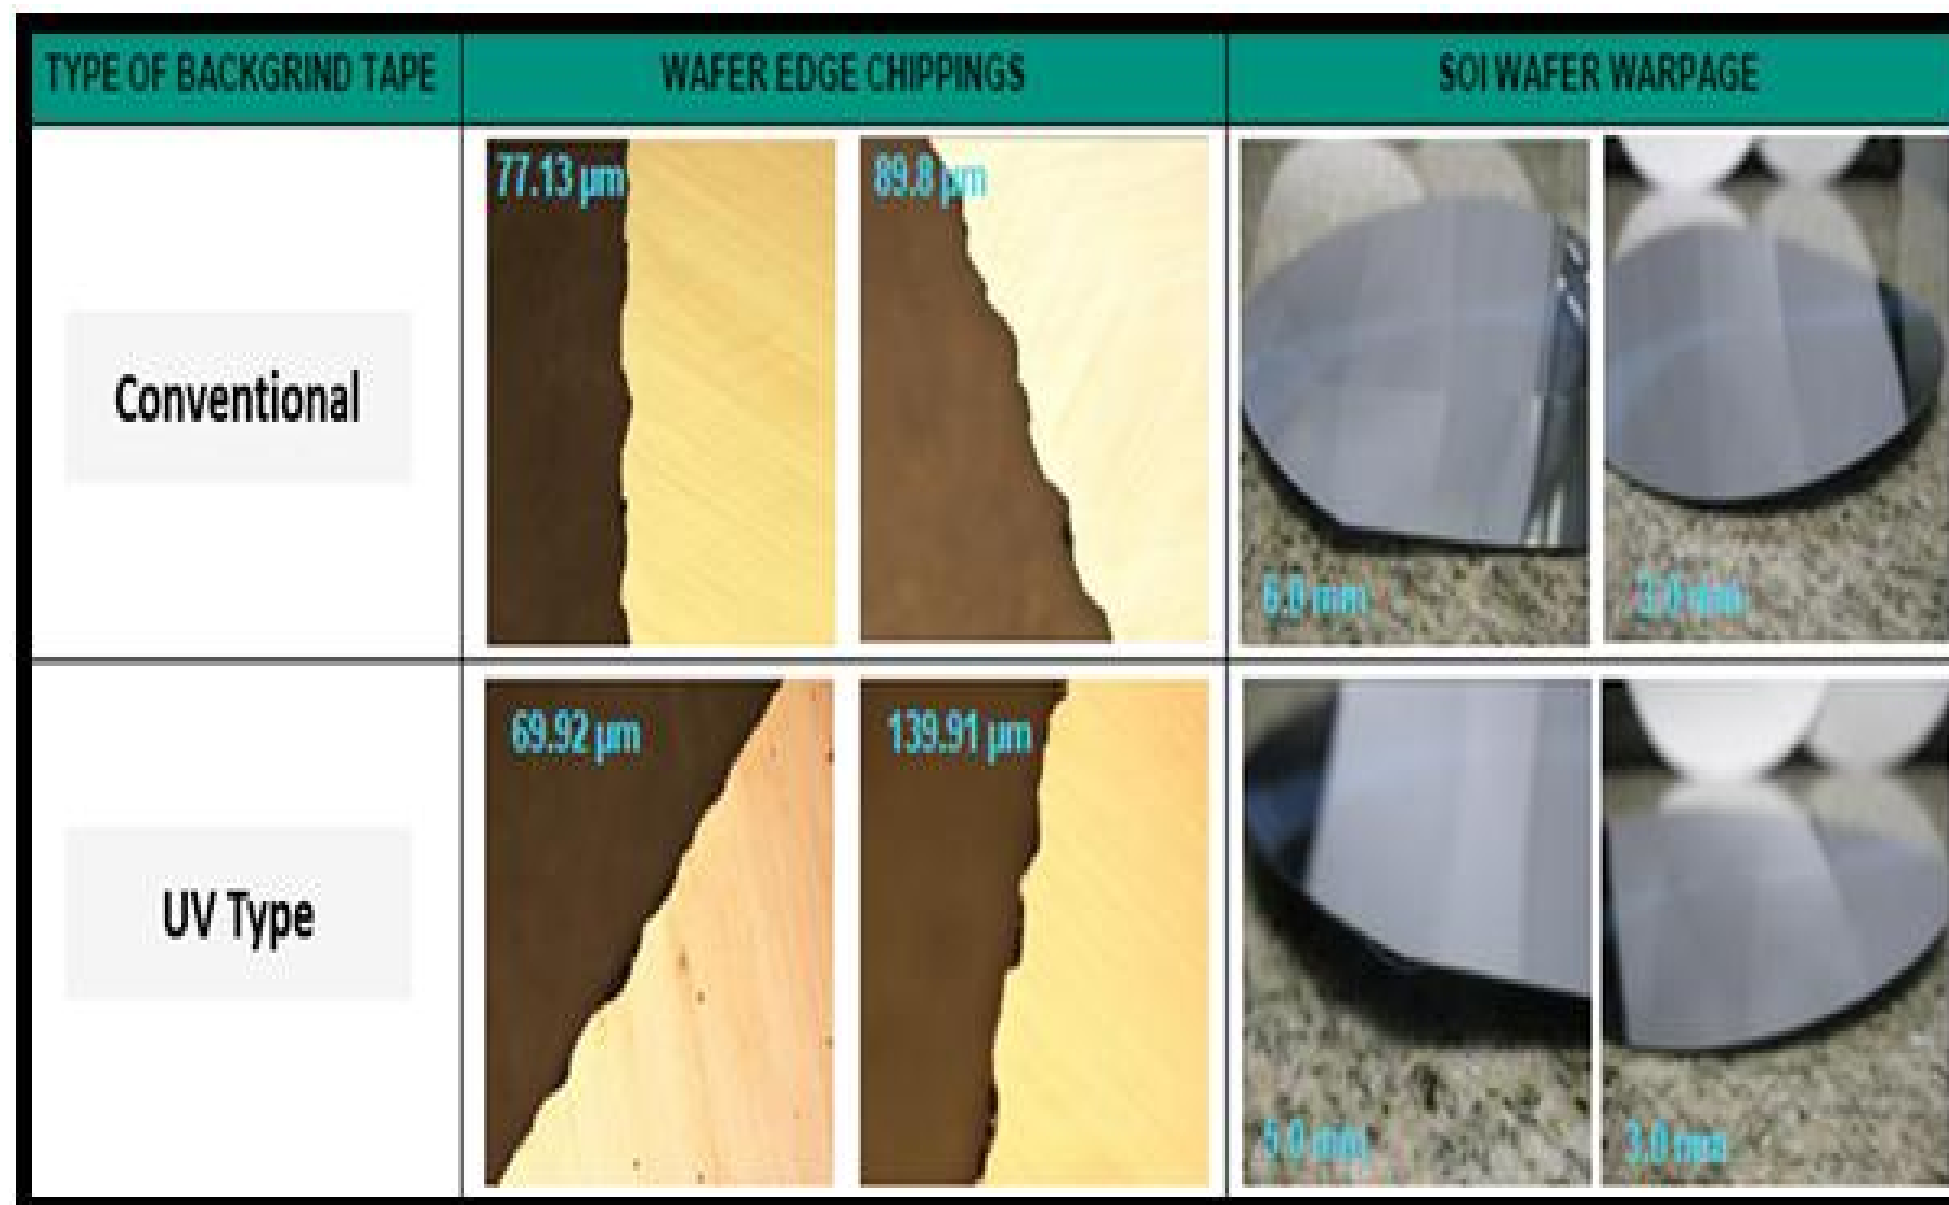
Both BG tapes in Fig. 6 induced wafer edge chippings and wafer warpage. The amount of wafer warpage for both BG tapes shows comparable level after backgrinding. Wafer edge chippings are observed being similar for both BG tapes. The readings of both tapes showed potential cause of wafer breakage. Both BG tapes have not been successful to be processed using the full auto mode due to its high warpage during the unloading. The robot arm vacuum is not enough to handle even the minimum warpage of 3.0mm.

Fig. 6. Wafer edge chipping and wafer warpage after backgrinding

Table 2 summarizes the risk level of the evaluated BG tape configuration, having no significant effect across all critical wafer backgrinding responses, namely broken wafer, wafer edge chippings and warpage. Moreover, wafer surface structure has significant effect on the quality index of its wafer backgrinding manufacturability.

For future works, detailed mathematical model and measurement indexes should be considered and qualified. For further improvement, it is highly recommended to use high vacuum efficient chuck table to properly handle incoming wafer warpage and ensure good flattening on the chuck table and eliminating the possibility of inferior grinding. Redesign of special robot arms should also be considered to eliminate the possibility of wafer breakage when handling or unloading thinner wafers after grinding or use an inline BG-mount system. Moreover, a special process should be considered wherein making an outer circumference lip, where no grinding pressure is applied on the edge of the wafer during backgrinding. For ensuing critical processes like that of the wafer saw, discussions in [9] are helpful to prevent or eliminate defects related to wafer preparation. Also, it is highly important that the assembly manufacturing processes ensure appropriate ESD checks and controls. Discussions quoted in [10] are very helpful to comprehend ESD-related controls.

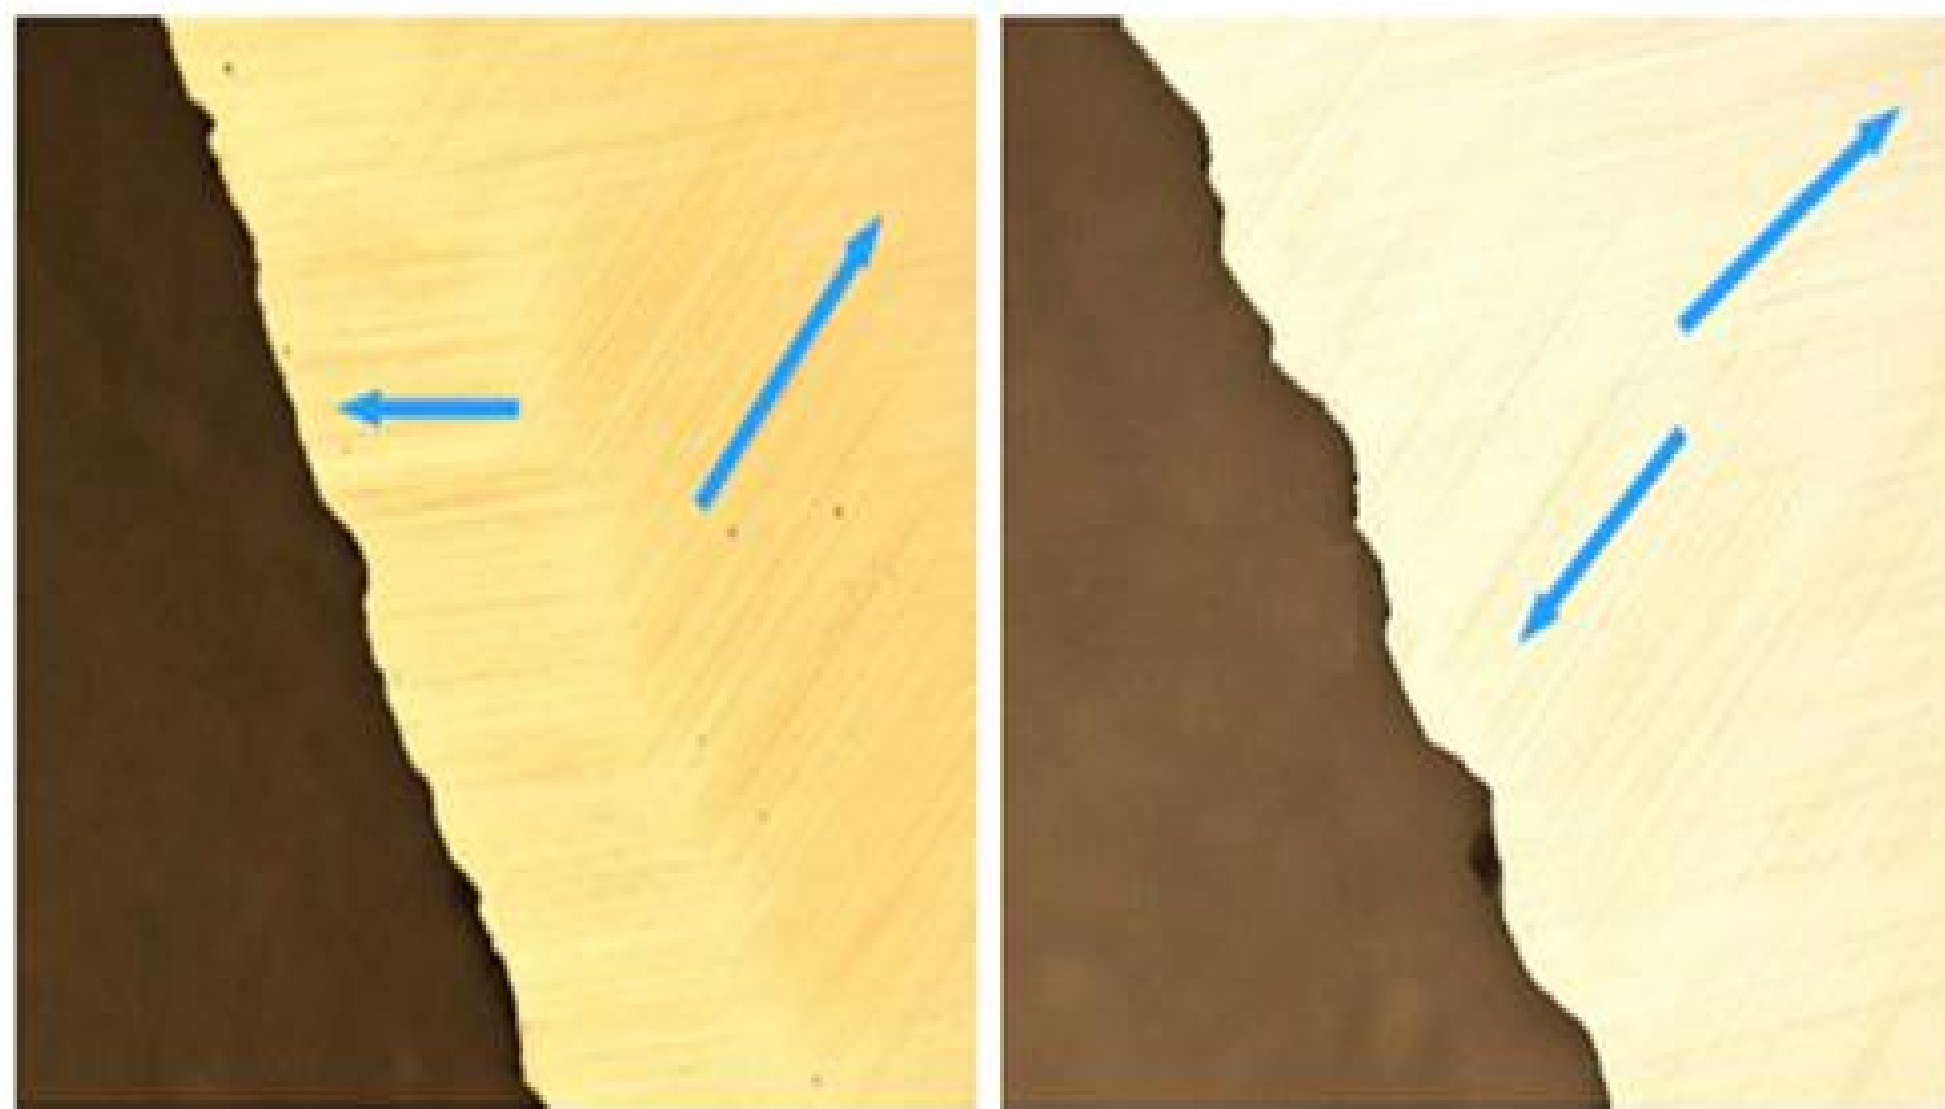
Back side image of the wafer has also been inspected using high magnification microscope as shown in Fig. 7. Uneven surface was observed at the edge of the wafer, which can also be considered a potential cause of broken wafer during process of transporting wafer from one station to another at pre-assembly. Also, the occurrence of uneven surface at the back of the wafer also coincide with the step at the edge of the wafers.

Fig. 7. Back side image of the SOI wafer
